FINAL REPORT

February 2002

Seismic Rehabilitation Alternatives for the Ahwahnee Hotel Yosemite National Park, California

Indefinite Quantity Contract No. I443CX2000-97-028
NPS Seismic Safety Program (2001-A250-405)

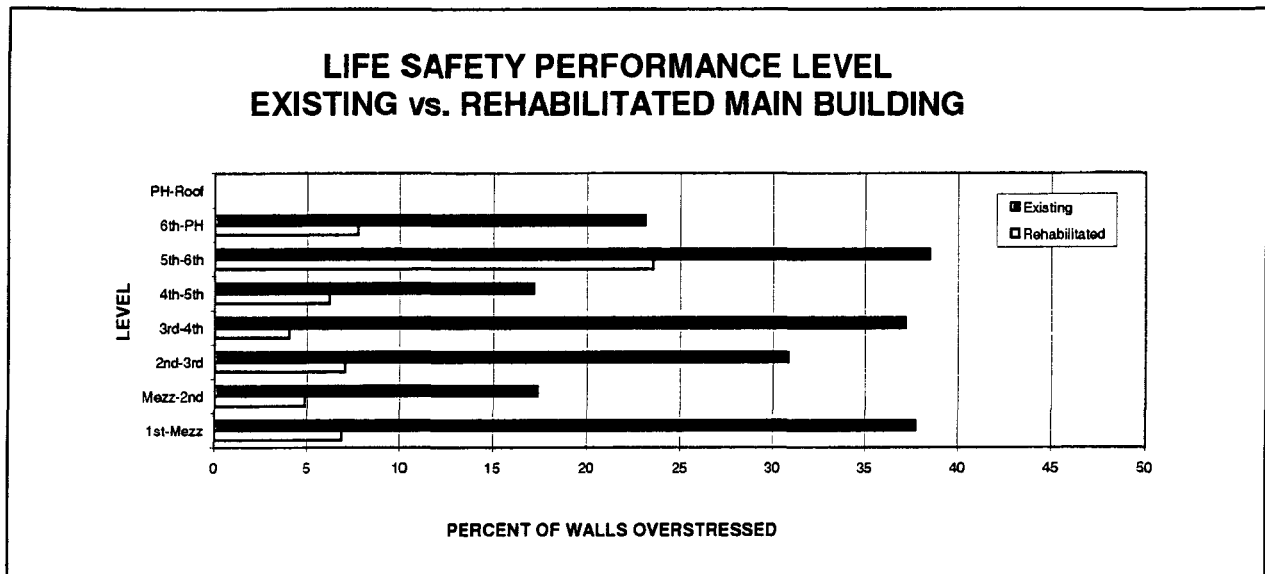
**FIGURE 4.1 LIFE SAFETY PERFORMANCE LEVEL- (EXISTING vs. REHABILITATED)
EVALUATION RESULTS OF SHEAR WALLS IN MAIN BUILDING**

Figures 4.1 and 4.2 illustrate that the proposed modification schemes will substantially reduce, but not totally eliminate, overstressing in the shear walls. Further refinement of the proposed schemes will be accomplished as part of the final retrofit design, and this will result in additional reductions in overstressing. However, a scheme that totally eliminates overstressing is both impractical and not warranted from a seismic safety perspective. Such a scheme would be impractical because of prohibitive cost and conflicts with historic preservation objectives. Such a scheme would be unwarranted because the building is capable of meeting the Life Safety and Limited Damage Objectives with the degree of overstressing shown by the unshaded bars in Figures 4.1 and 4.2.

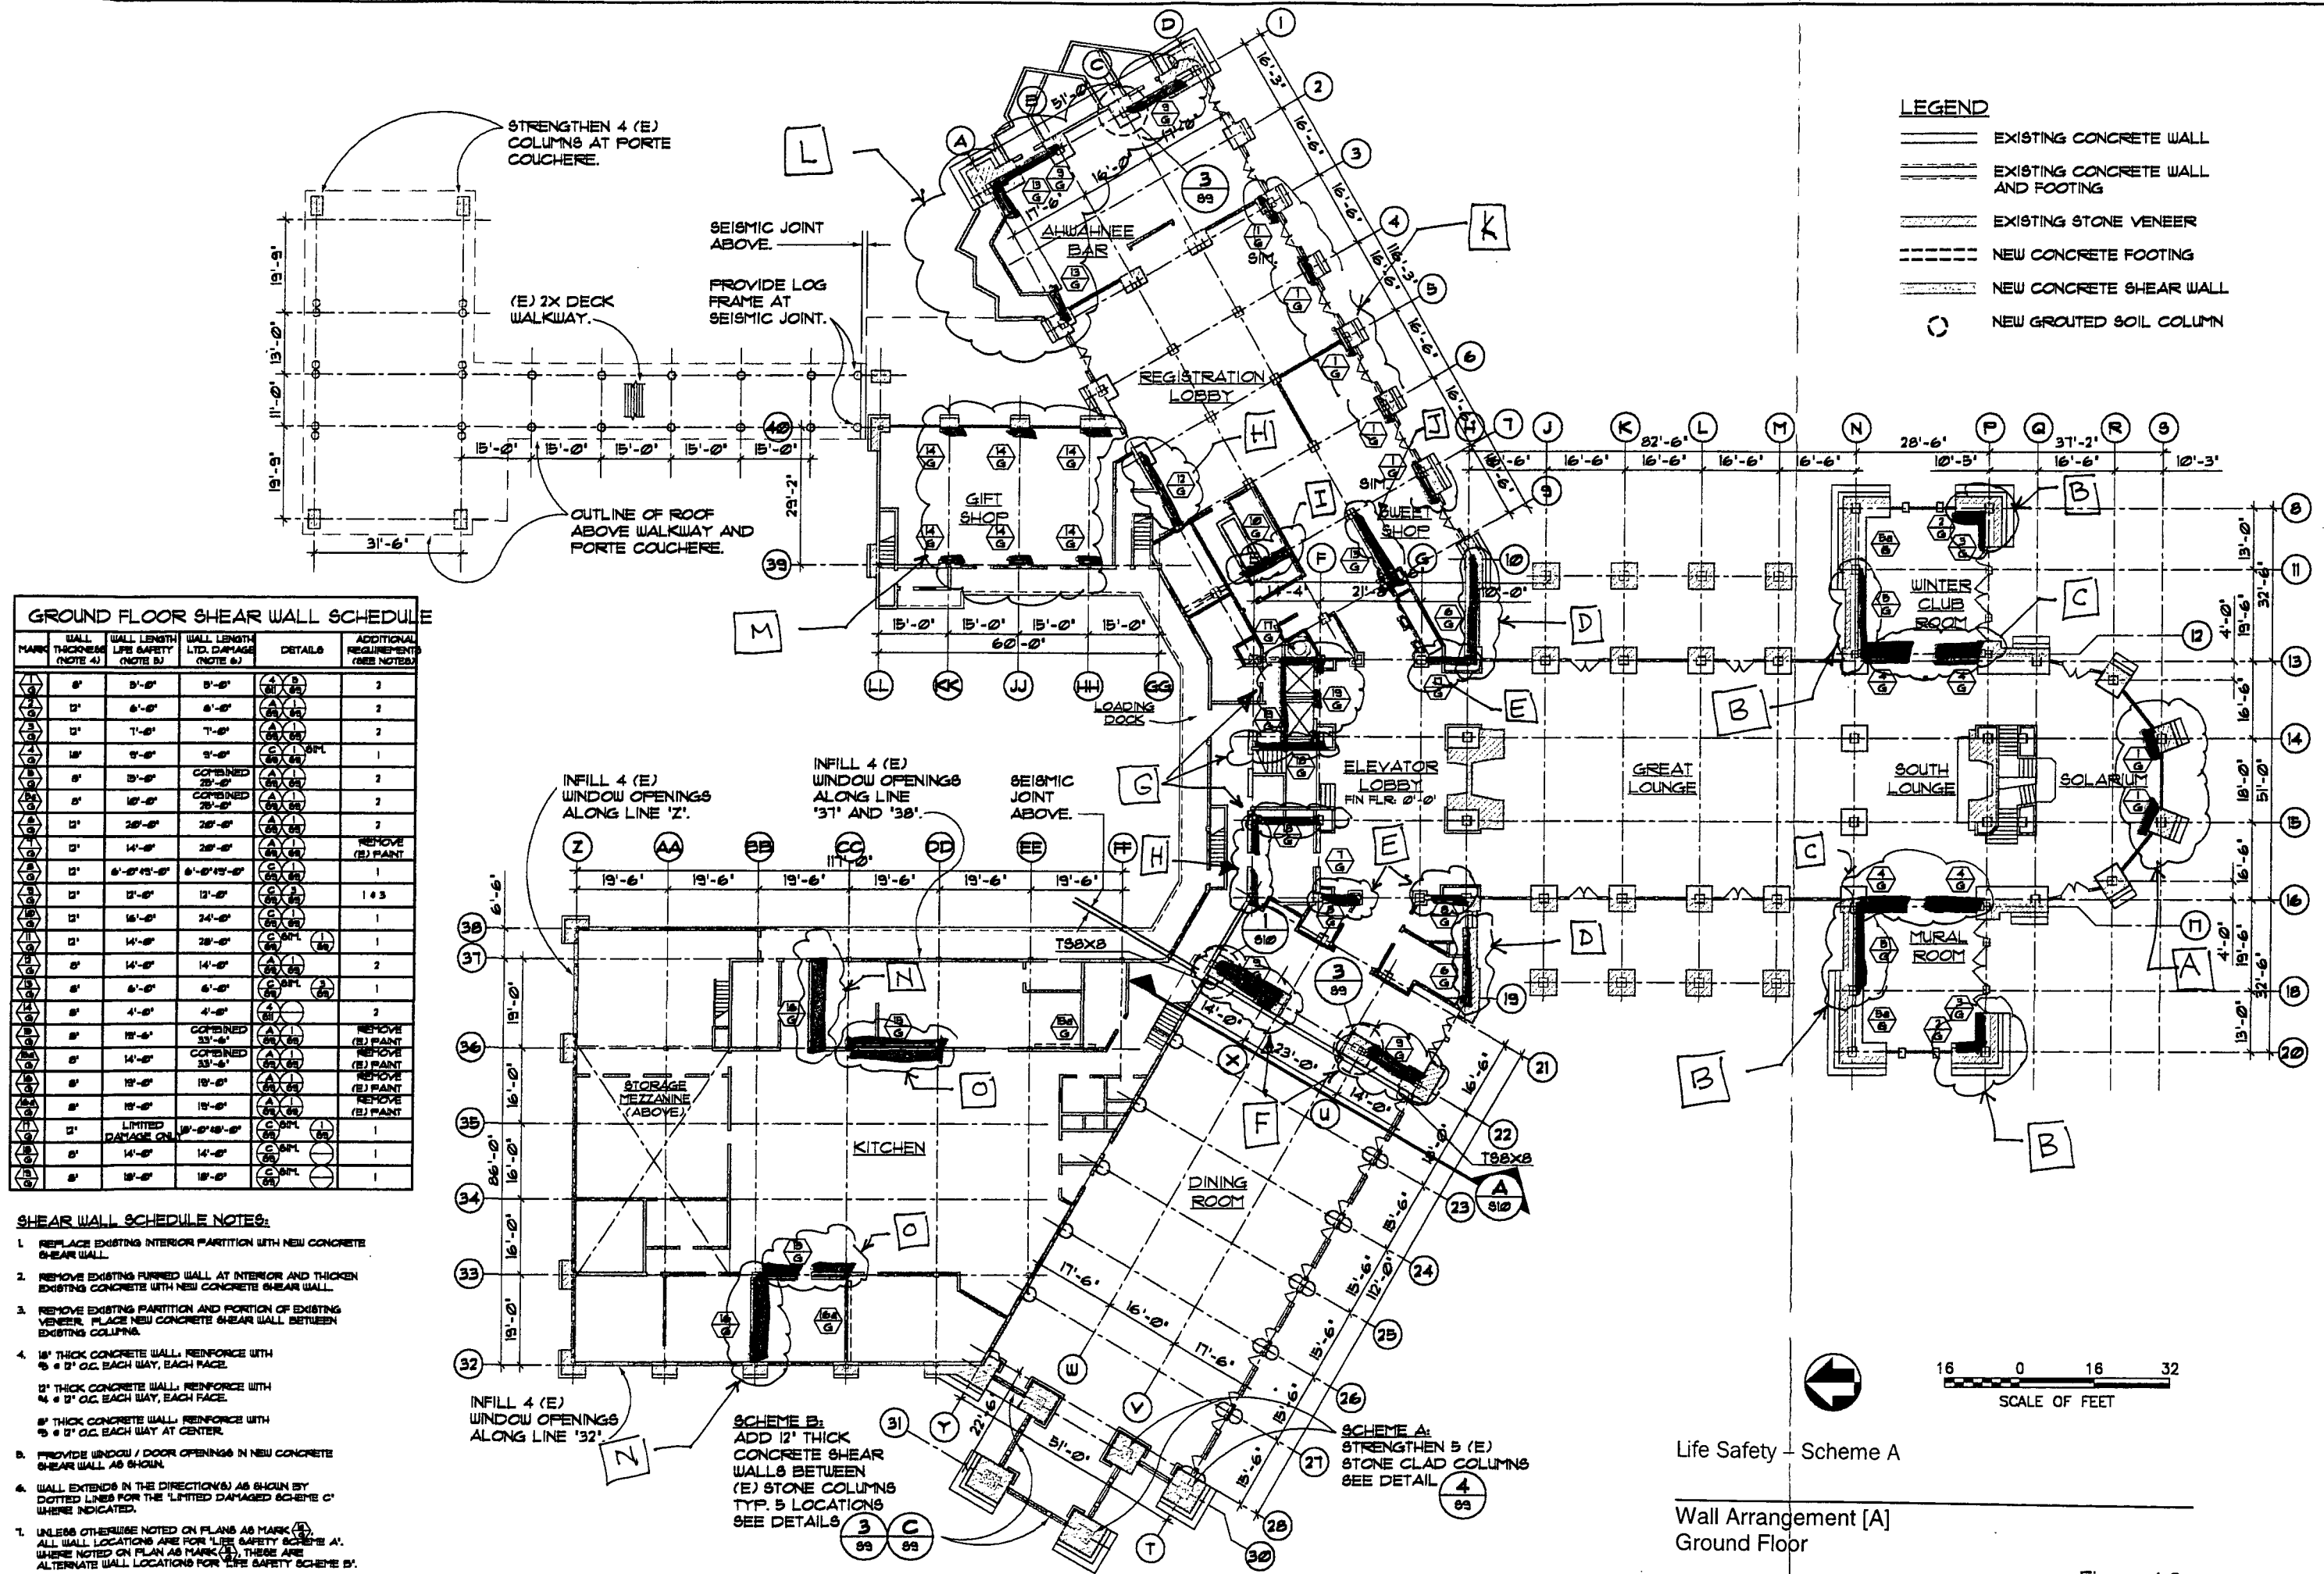
The new or modified walls at ground floor level are located in Figure 4.3. The reasons for these walls are as follows:

- SHEAR WALL SCHEDULE NOTES:**
1. REPLACE EXISTING INTERIOR PARTITION WITH NEW CONCRETE SHEAR WALL.
 2. REMOVE EXISTING TURNED WALL AT INTERIOR AND THICKEN EXISTING CONCRETE WITH NEW CONCRETE SHEAR WALL.

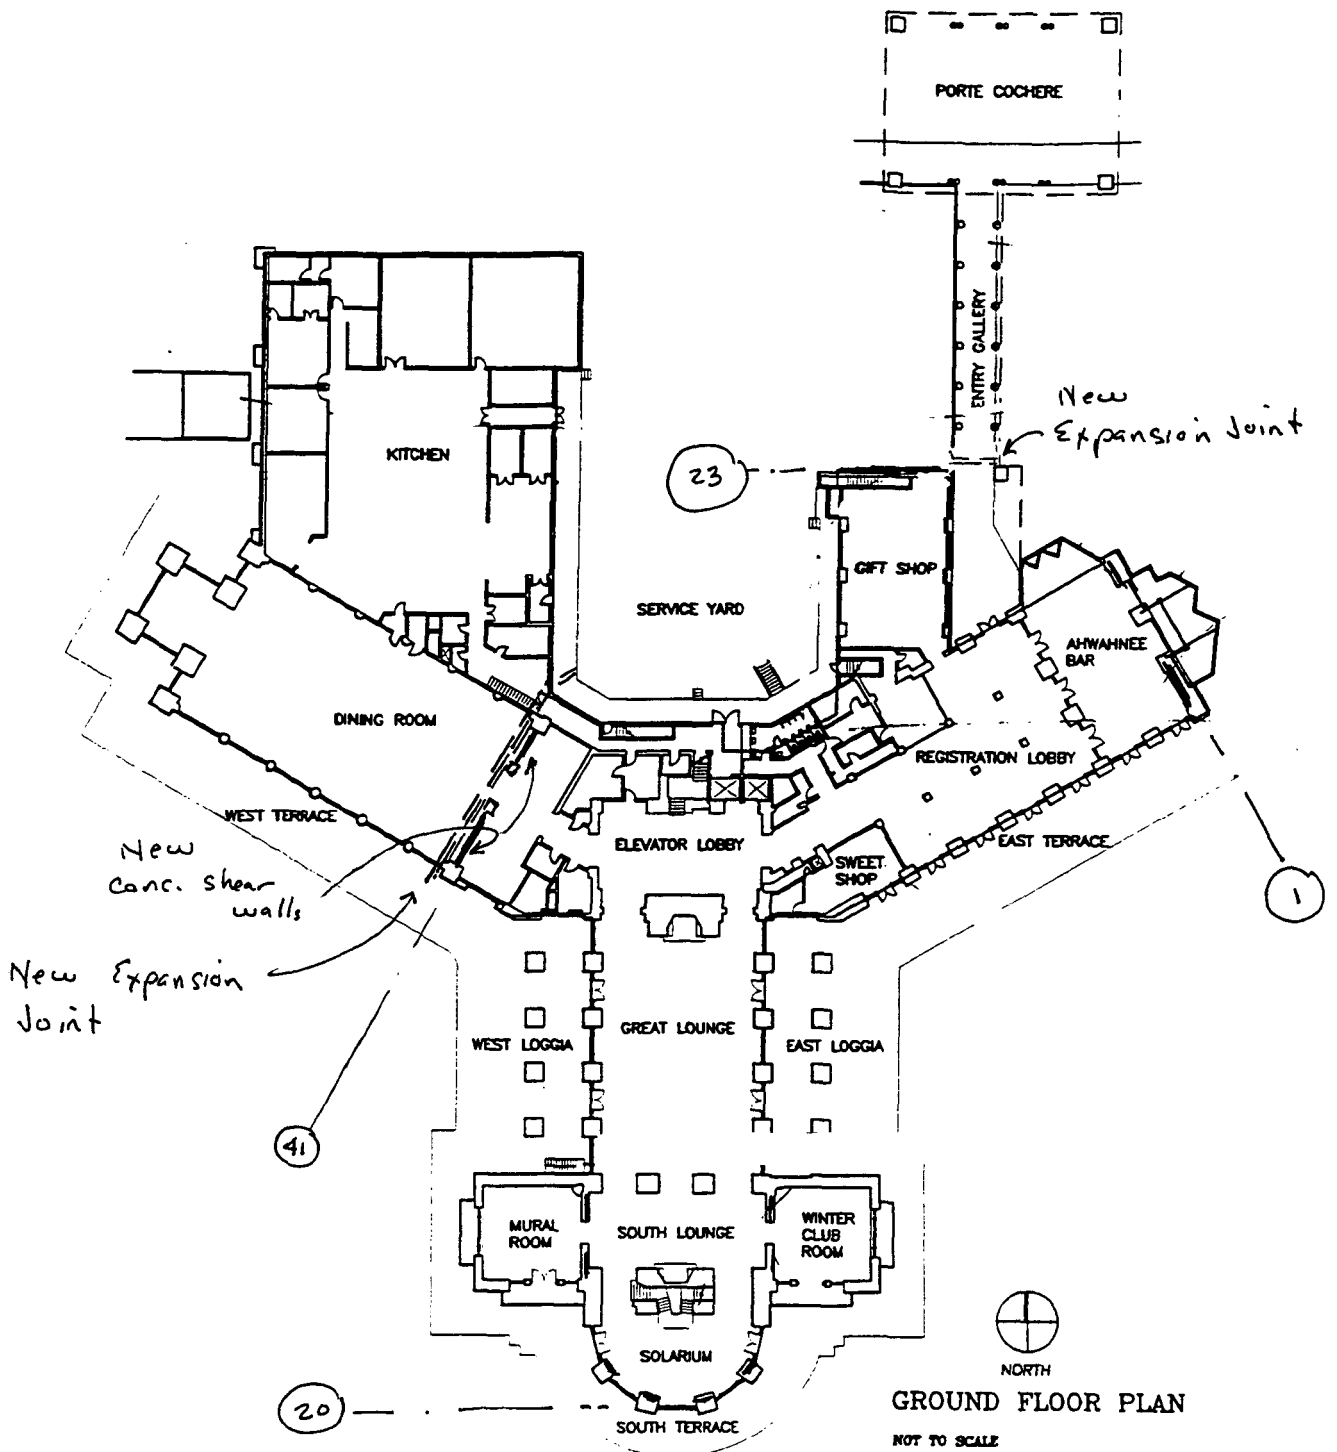
Dividing the building into three separate structures as proposed above would also increase the building eccentricity, thus increasing the torsional shear forces at the ends of the building wings. It is expected that new shear walls would be needed at column lines 1, 20, 41, and 23, as shown in Figure No. 1. The existing concrete shear wall at column line 23 may need to be strengthened. New walls at column lines 1, 20, and 41 will be discussed later in this report.

Retrofit design can be accomplished by dividing the building into three separate buildings, as shown on Figure No. 1. Concealed expansion joints could be added without affecting the historical fabric of the building. The three separate buildings would consist of: (1) the multistory main building (a steel-frame structure with concrete shear walls; see Photo No. 1)); (2) the one-story combined Dining Wing and Kitchen Wing (the Dining Room is a timber / concrete structure and the Kitchen is a steel frame / concrete structure); and (3) the combined one-story Porte Cochere and Entry Gallery Structure (wood frame structure; see Photo No. 2). The expansion joint between the main building and the dining room was also proposed in the Martin / Martin Report (FEMA 178 Seismic Evaluation - dated August 1999).

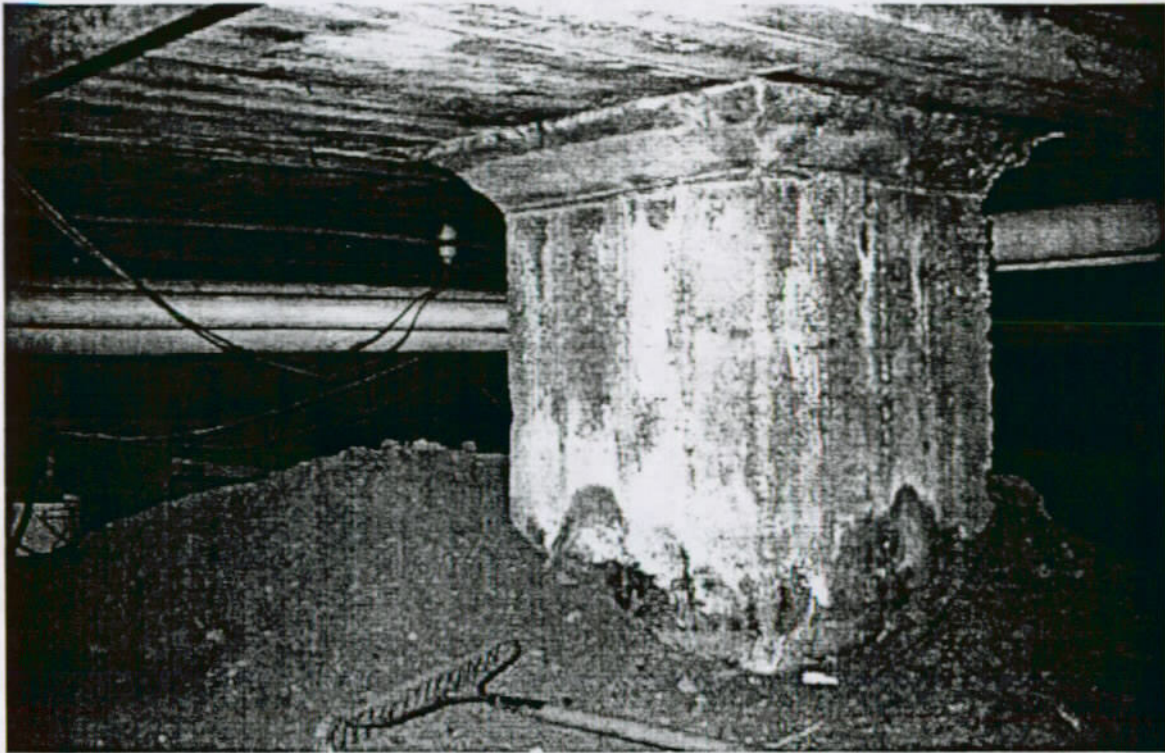
Photo No. 3 Crawl Space in South Wing

first floor. There are corridors of major piping runs and ducts and areas where utilities lie buried (see Photo No. 3). It would be appropriate to locate the new basement walls to avoid these areas. It would also be advisable to locate new walls so as not to close access to remote areas of the crawl space, or add new walls that would restrict future utility placement.

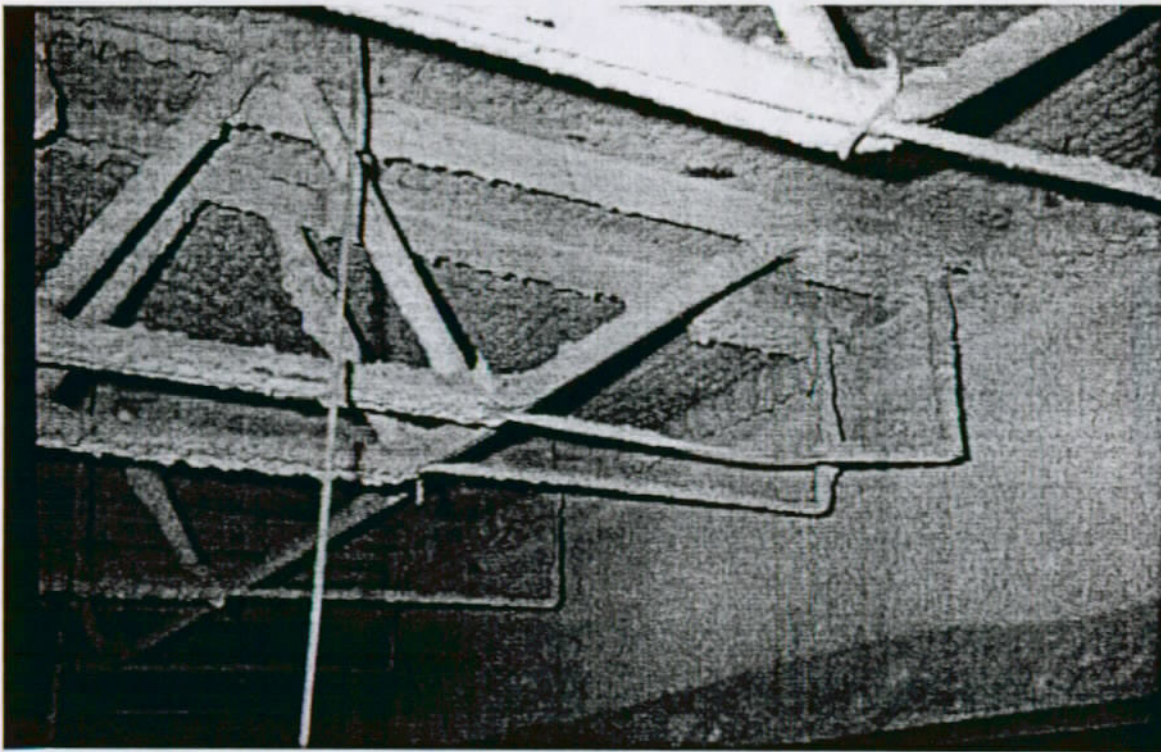
The first floor is a 10-inch-thick reinforced concrete suspended slab. This slab is a rigid diaphragm with apparent strength to distribute shear forces to the perimeter concrete walls. The floors above the first floor are not as rigid. The floors above are constructed of 2½-inch-thick concrete fill over metal lath. The concrete fill appears not to be reinforced. The concrete fill / metal-lath slab spans 2 feet between open-web joists (see Photo No. 4). The metal lath appears not to be welded or mechanically connected to the open-web joist. It appears to be secured in place with wire stays. There is some question as to whether the floor diaphragm is a rigid or a flexible diaphragm: in our future analyses, we will study it as both.

Photo No. 4 Typical floor diaphragm above the first floor.

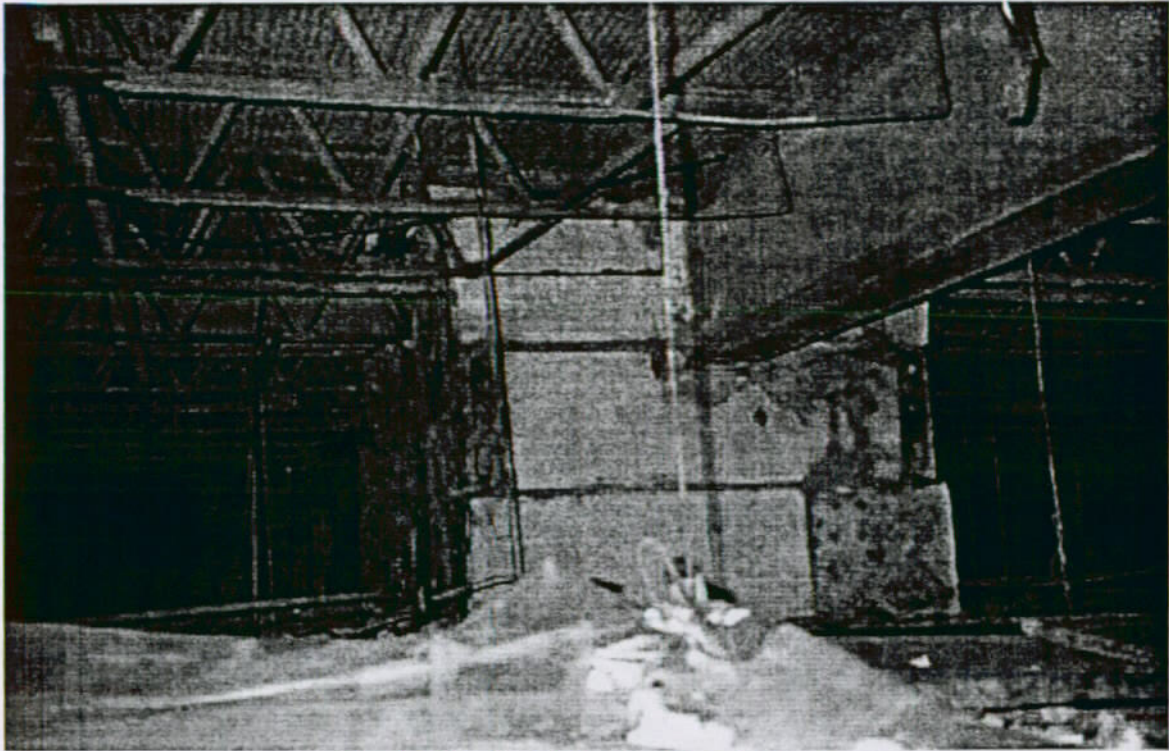
Room partition walls are constructed of 2½-inch-thick unreinforced gypsum block stacked in a running bond configuration. A ¾-inch thickness of plaster was added to both sides. These walls do not go to the floor above, but end at the ceiling. Pipe chases also constructed of gypsum blocks do go to the floor above (see Photo No. 5). This observation was made in an access hatch in the second floor laundry.

Photo No. 5 Clay Tile Pipe Chase

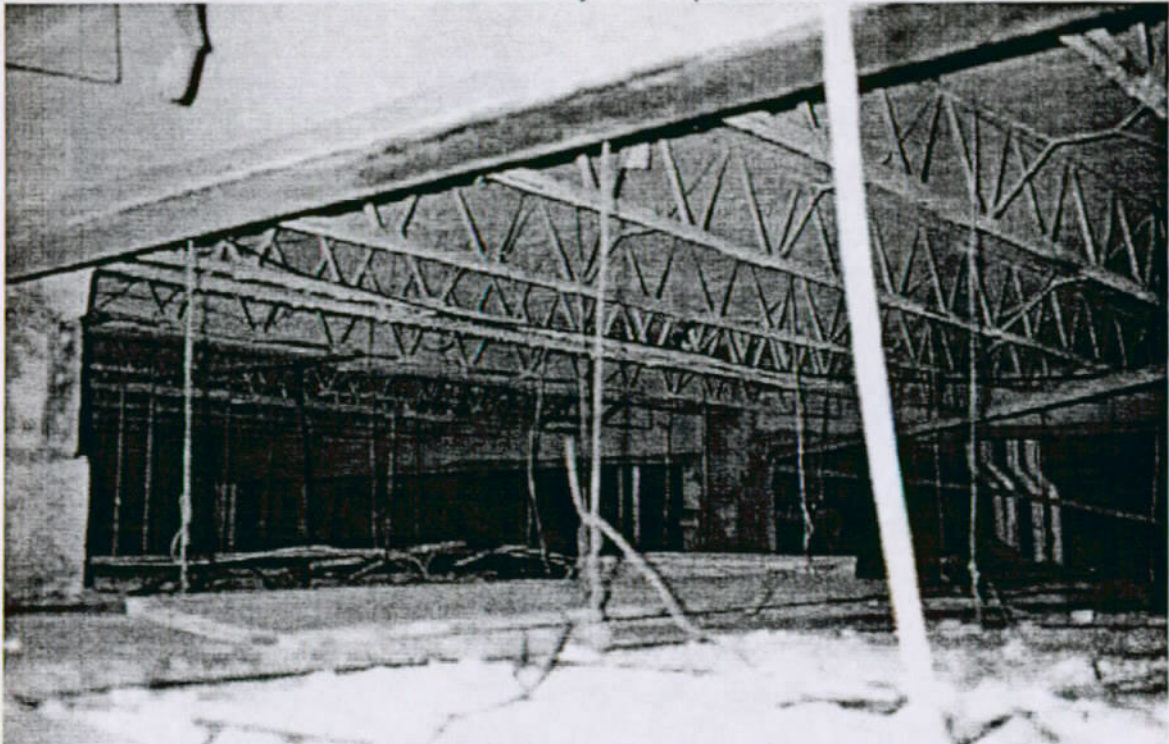
Except for the Dining Room, the ceilings are suspended metal laths with ¾-inch plaster. The ceiling is supported by wire at approximately 4 feet on center (see Photo No. 6). There were no diagonal wire supports to prevent lateral movement of the ceiling during an earthquake.

Photo No. 6 Suspended Metal Lath and Plaster Ceilings

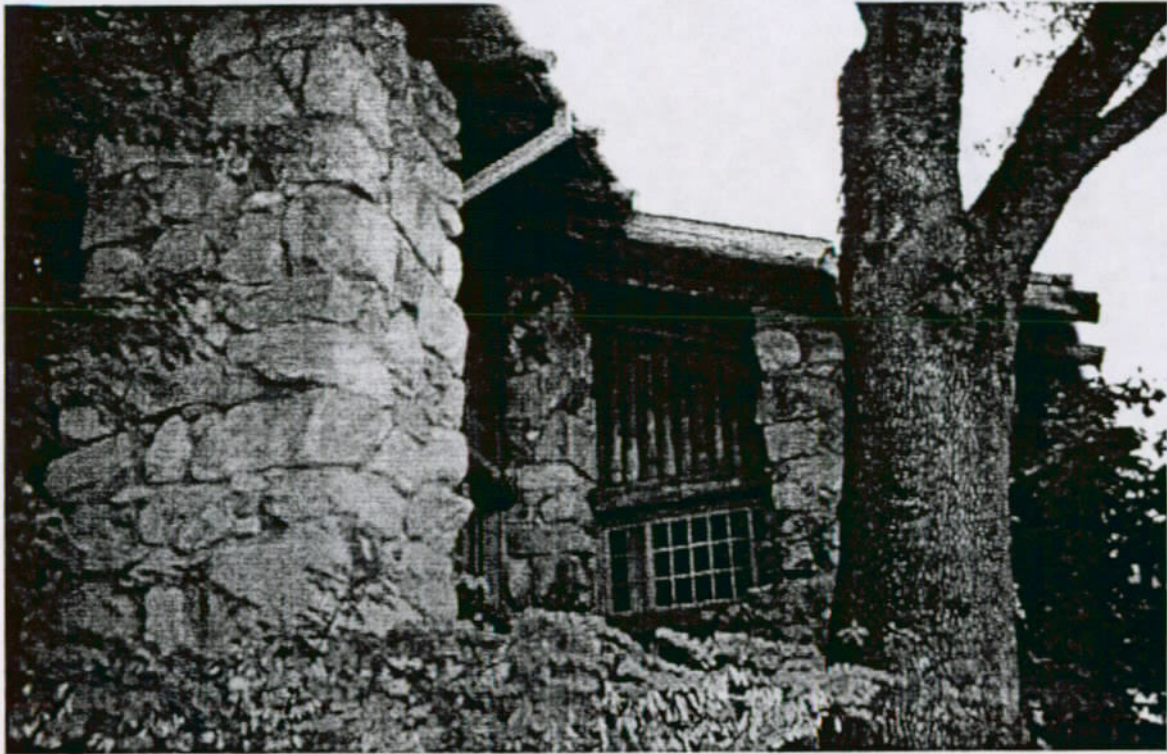
Photo No. 7 Granite Veneer

It would be advisable to remove one or two of the smaller blocks from the exterior face of one of the dining room masonry columns, and also one or two small blocks from another masonry wall at the opposite end of the building. Also advisable is the removal of a small section of the roof above one of the corner-stone columns at the Dining Room to determine if the column core is filled with concrete or rubble (see Photo No. 7).

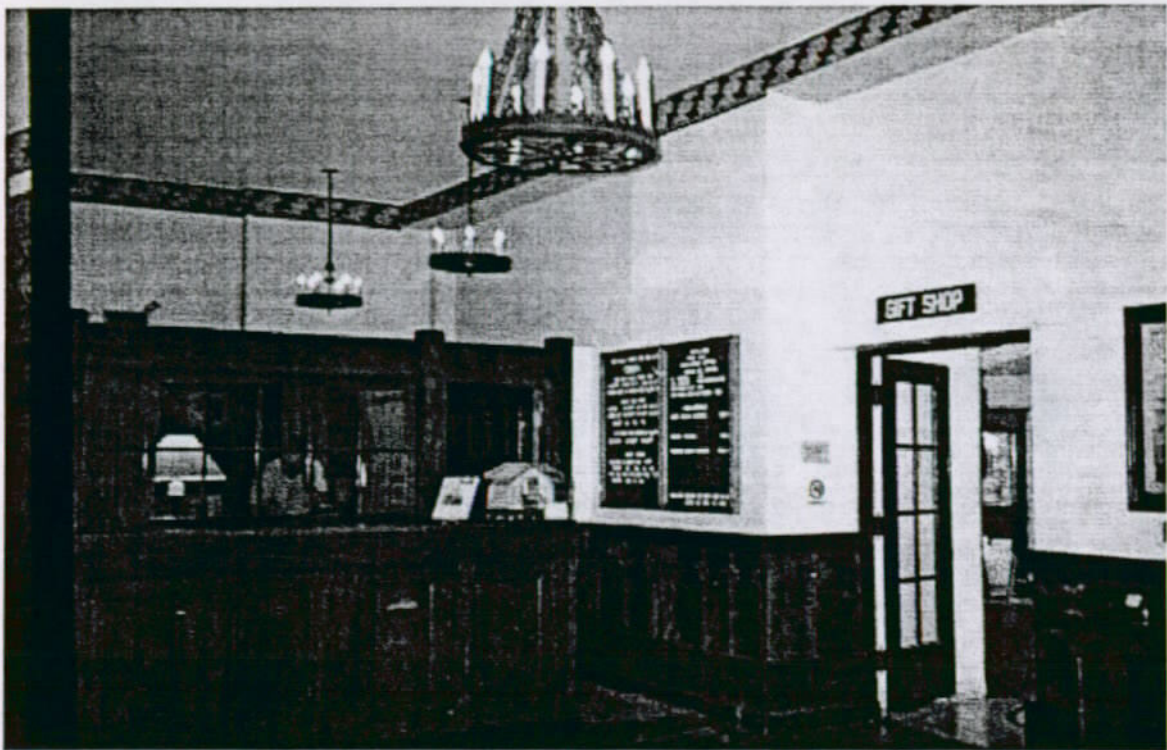
Photo No. 8 Existing partition to be converted to concrete shear wall.

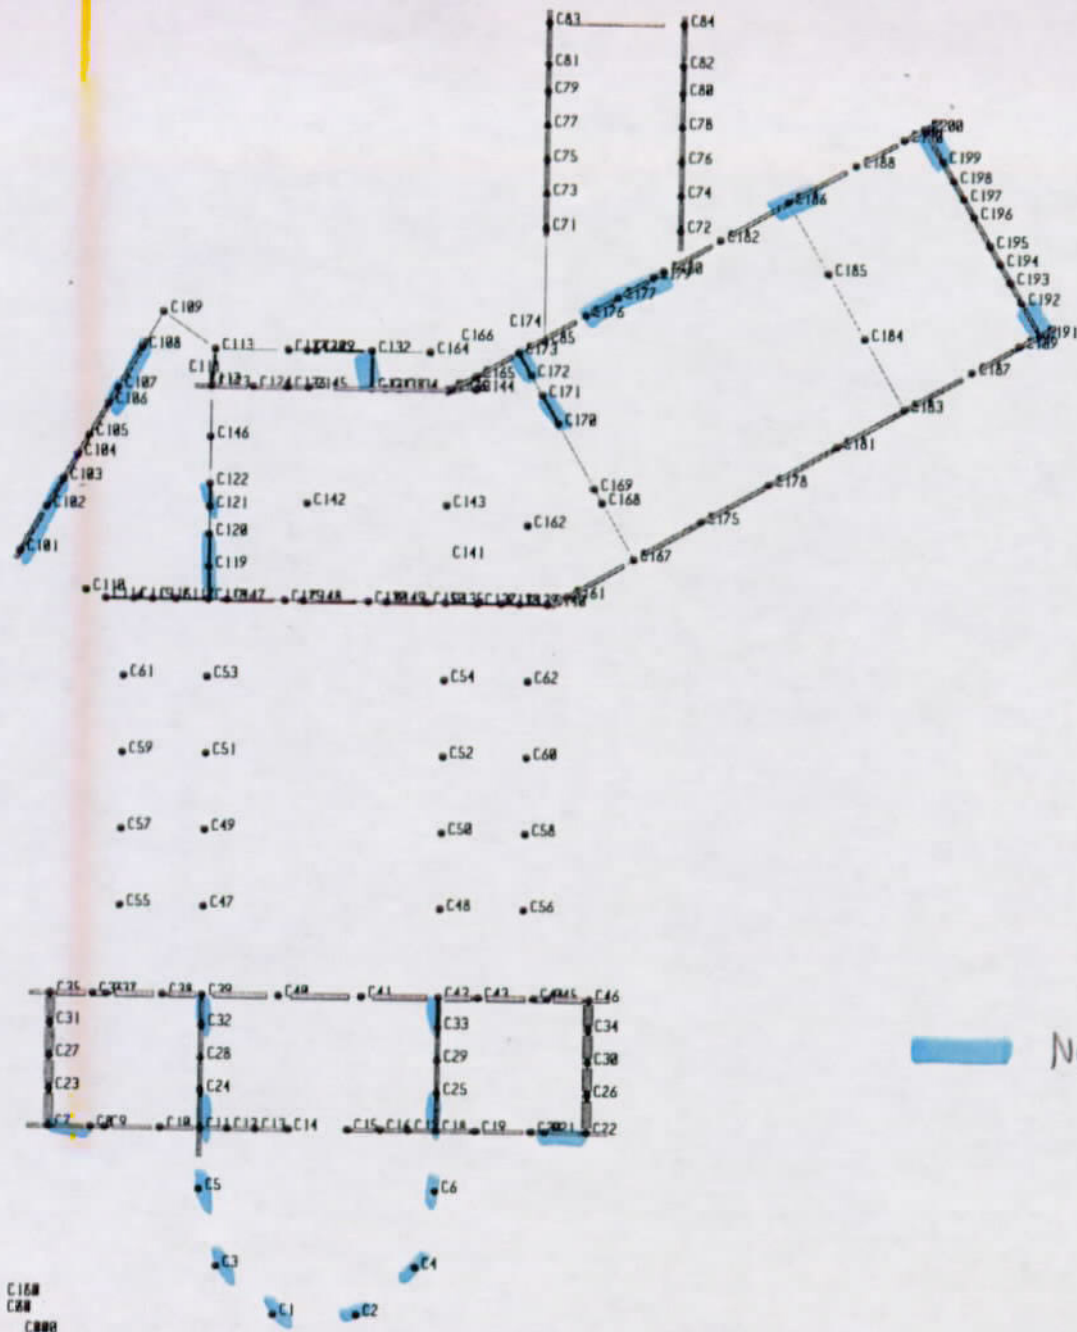
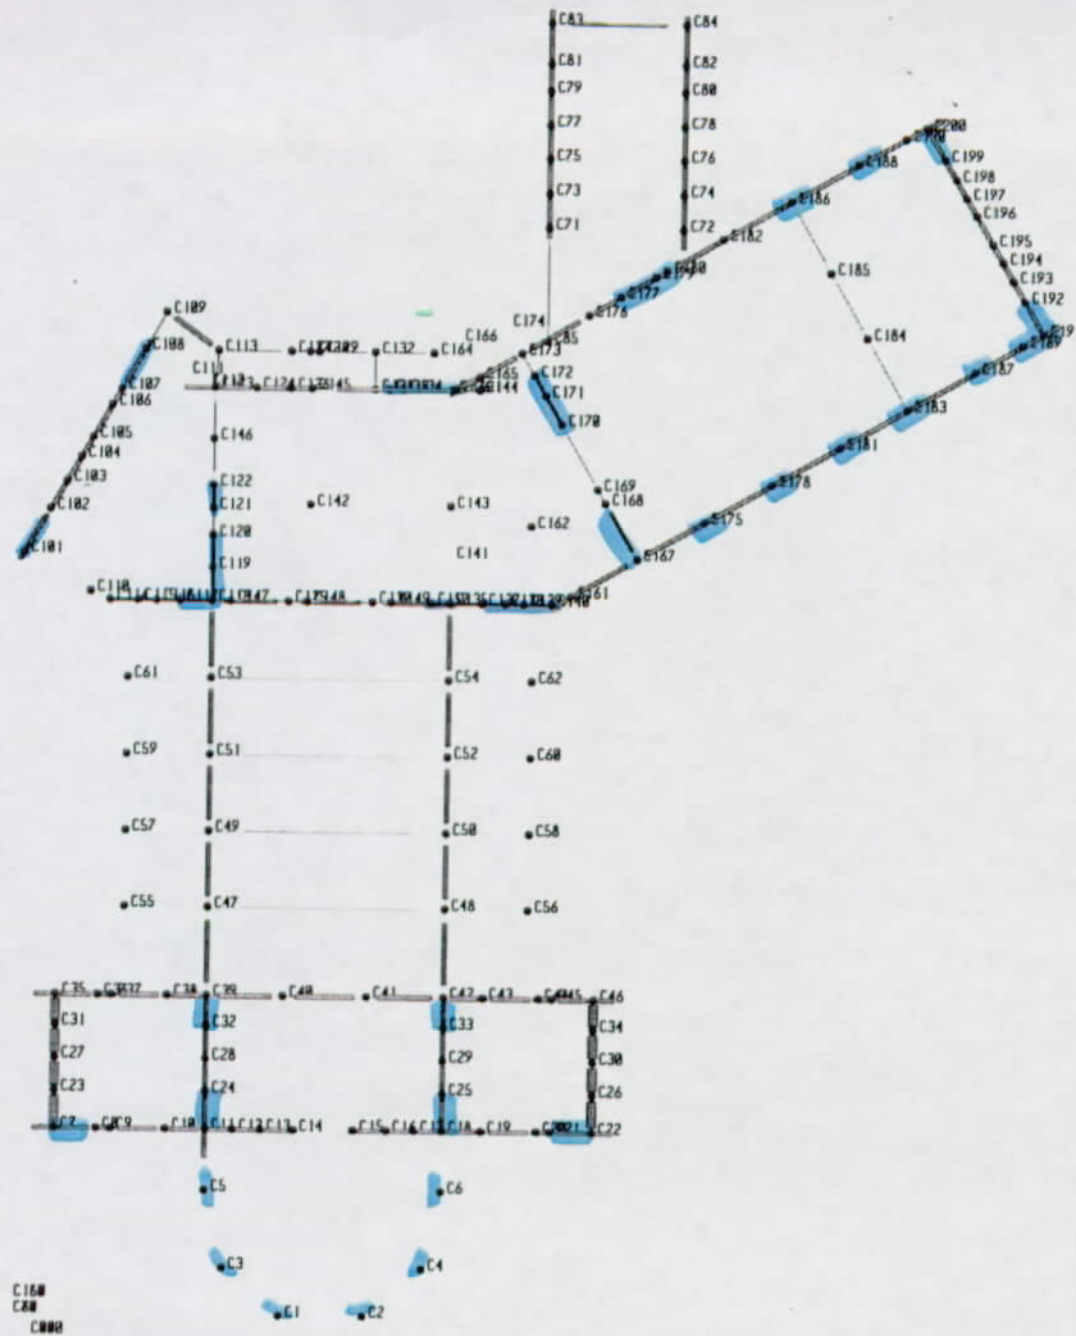
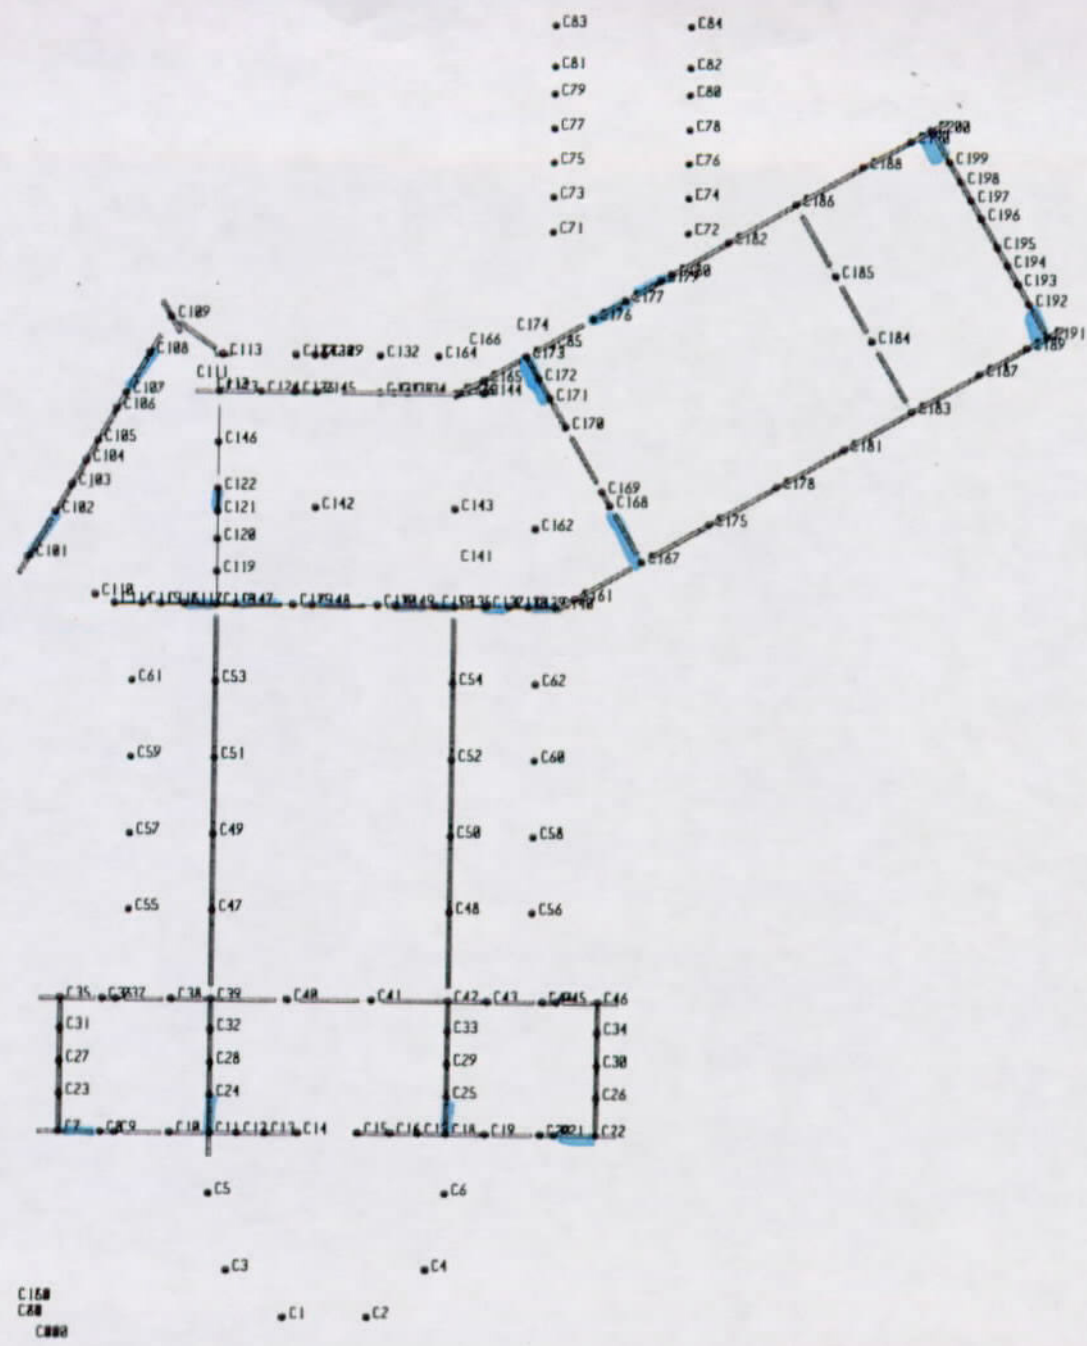
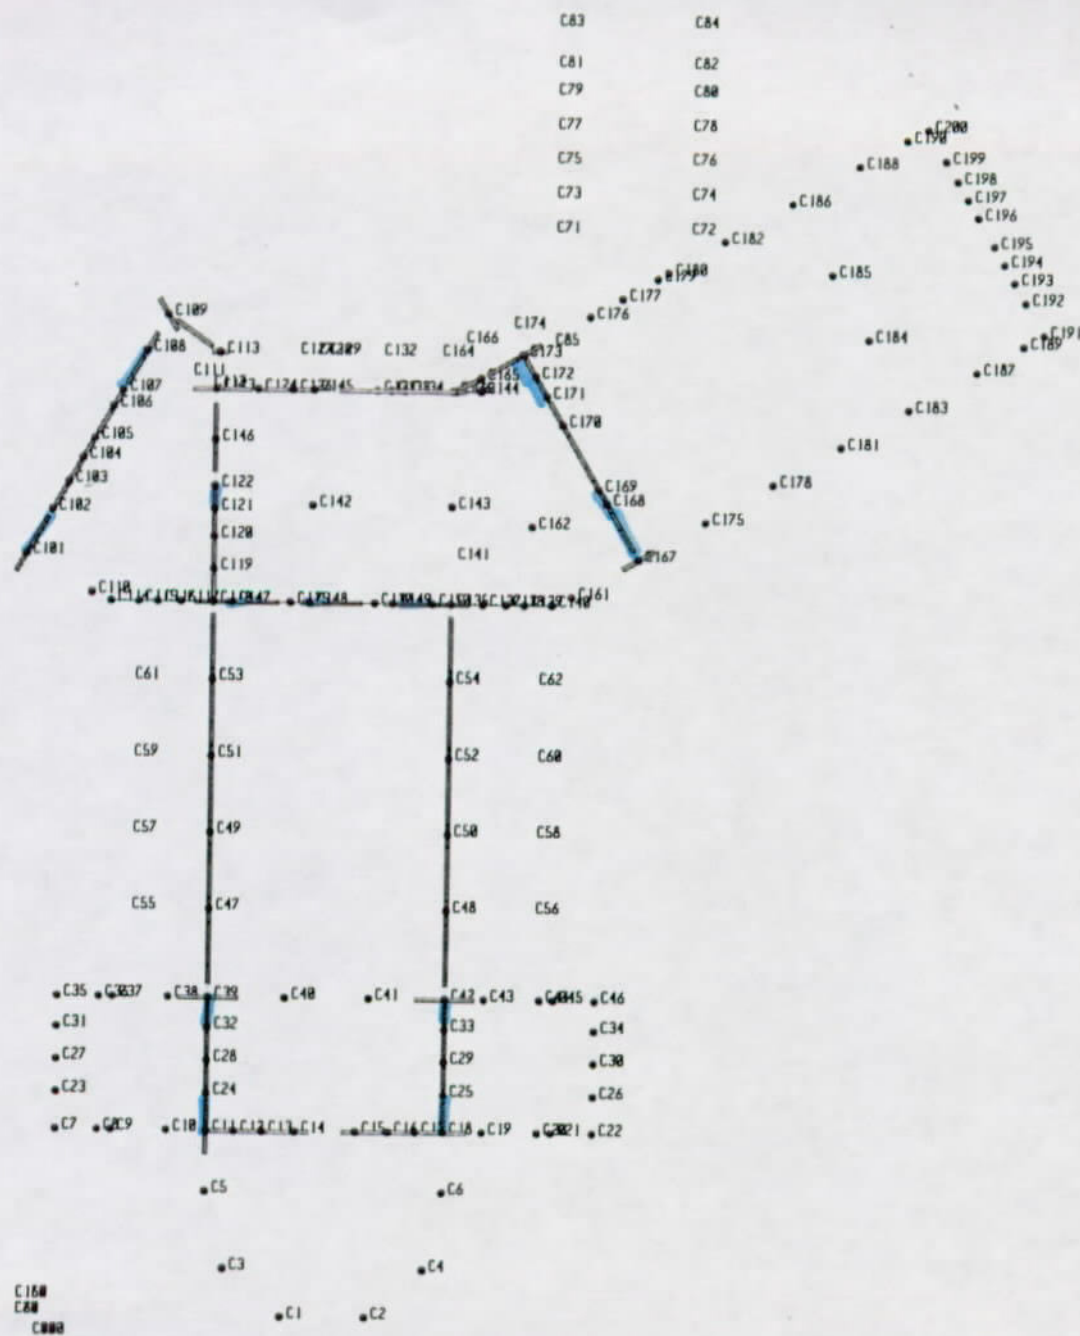
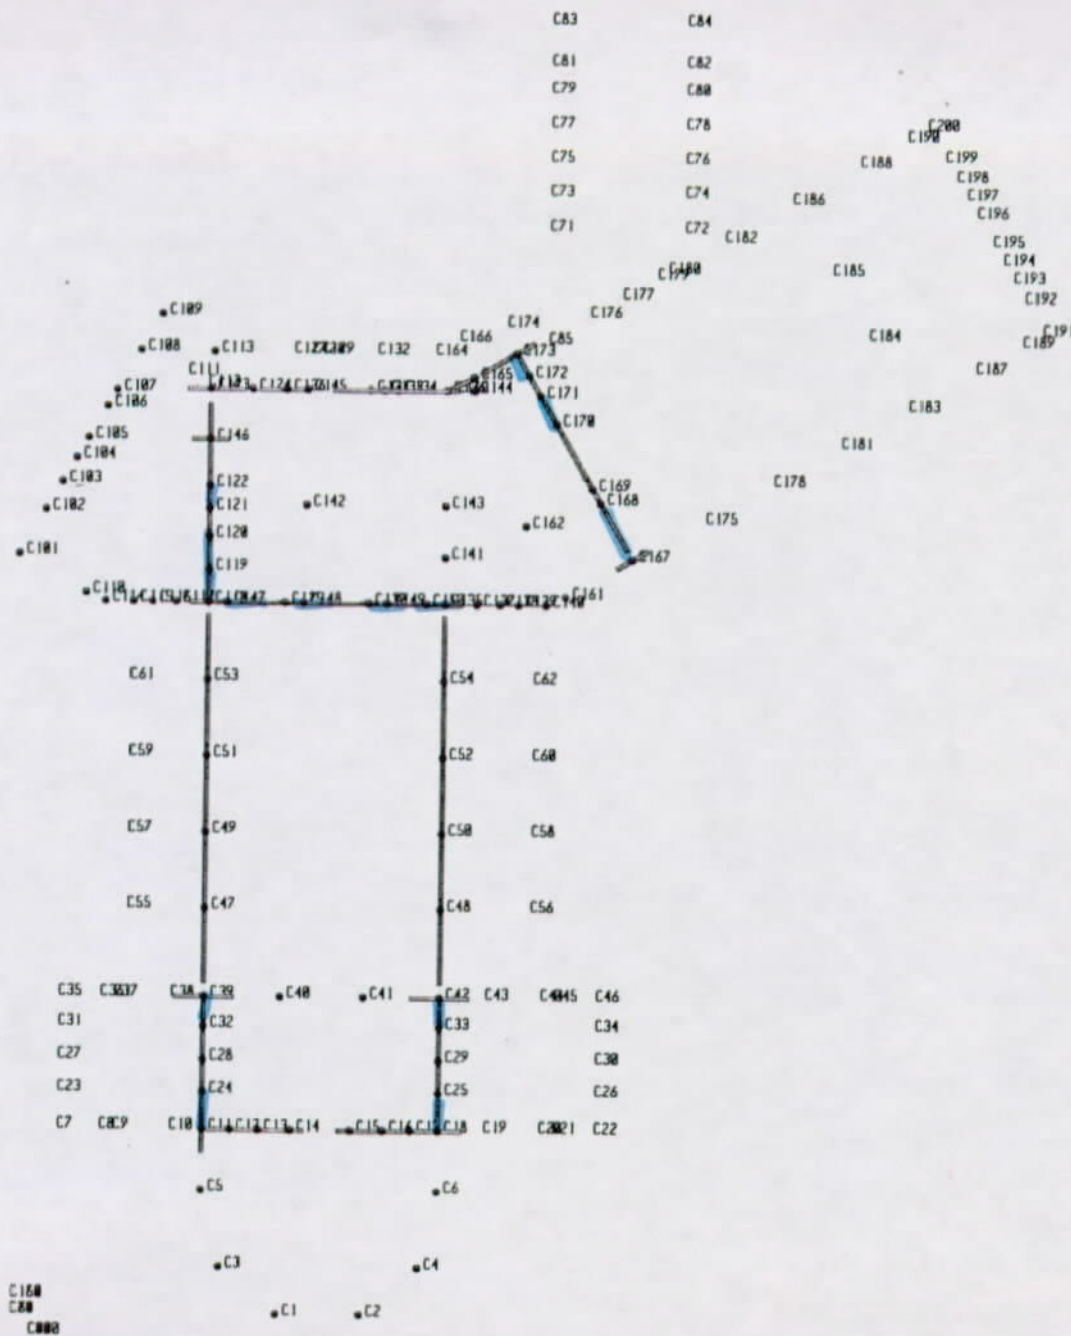
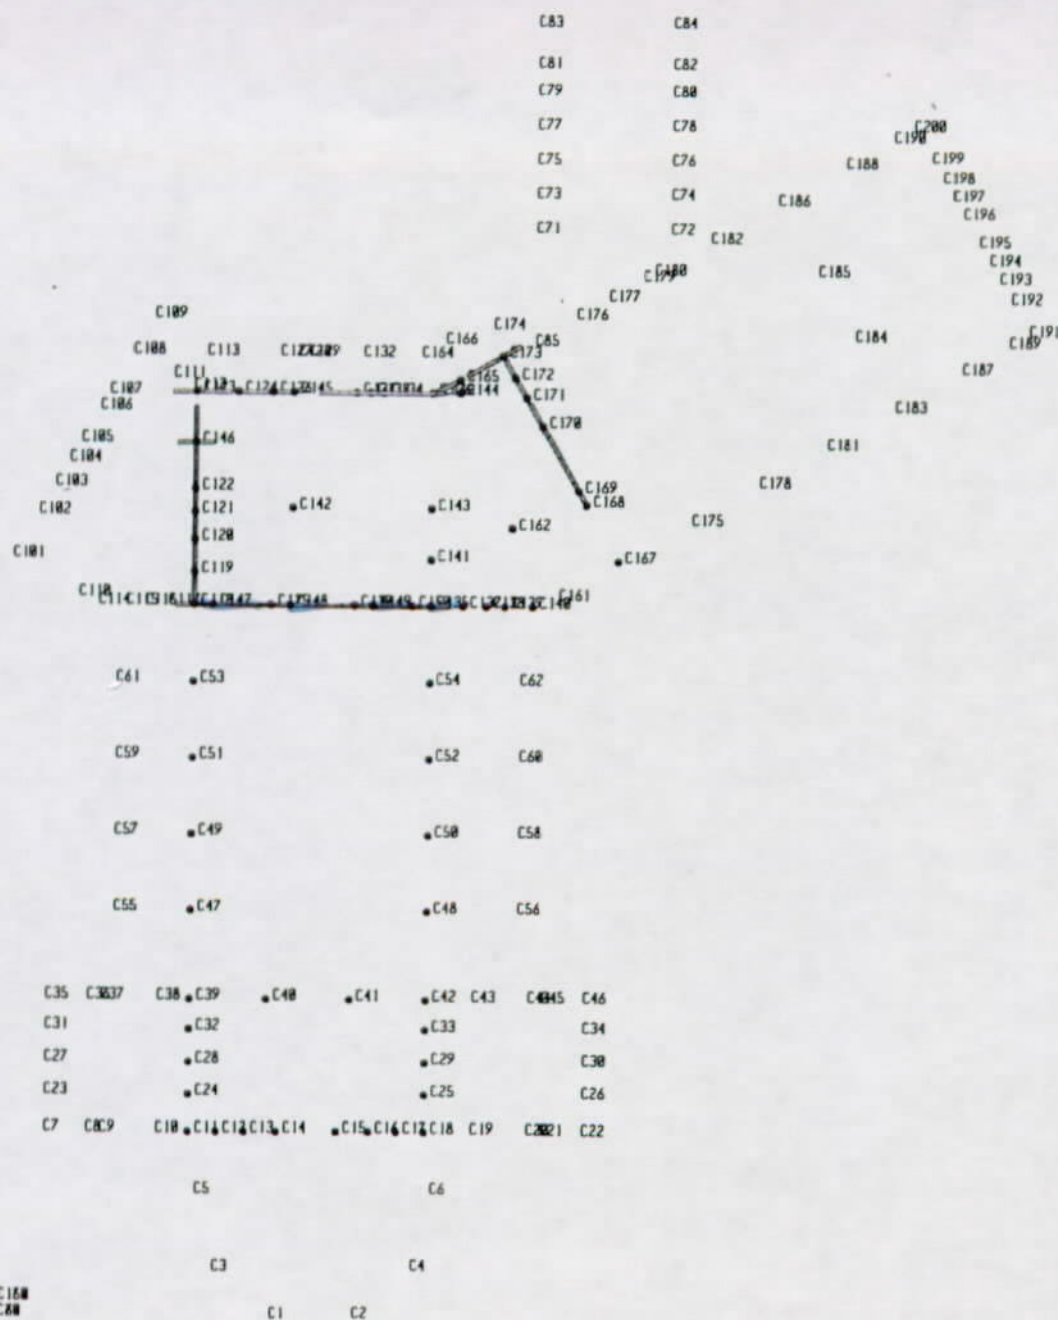
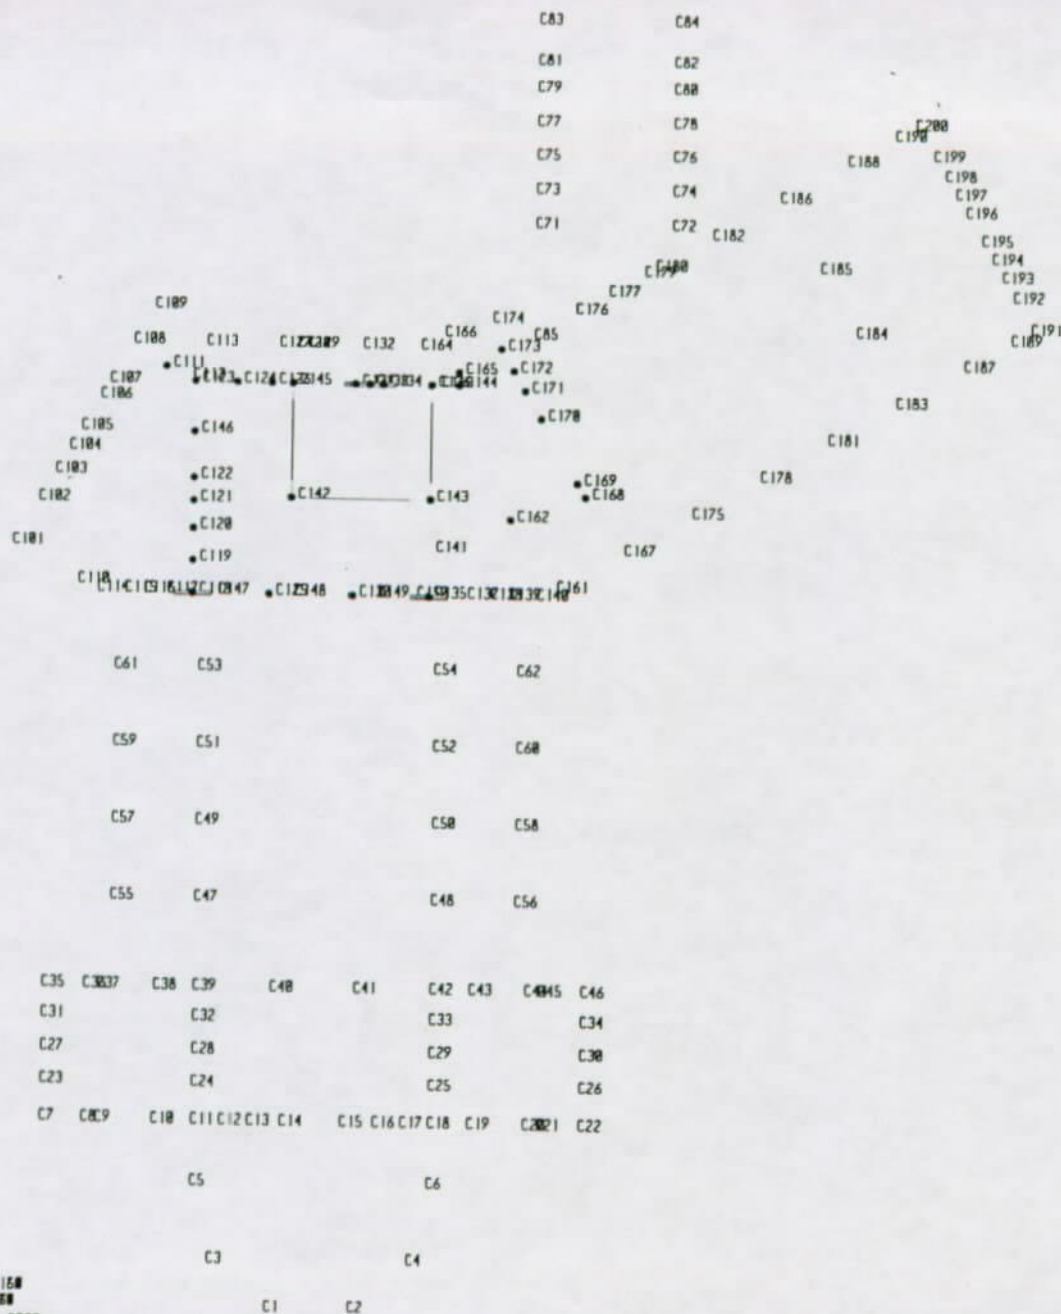
NEW CONC WALLS
